Project	North Sound Behavioral Health Treatment Center
Created	2020-08-17 10:05:01 PDT by Adam Johnson
Updated	2020-08-17 12:35:58 PDT by Adam Johnson

Project Name and Number	North Sound Behavioral Health Treatment Center - R16-180068.01
Location	902 Pine St., Everett, WA 98201
Observation Report No.:	14
Report Author	Adam L Johnson
Date of Visit	2020-08-17
Time of Visit	10:00
Weather Conditions	Sunny
Temperature (F)	75
GC/CM	BN Builders
Site Walk By	Jeff Hencz and Steve Slawson (SnoCo), Noah Foster (BNB), Adam Johnson (OAC)

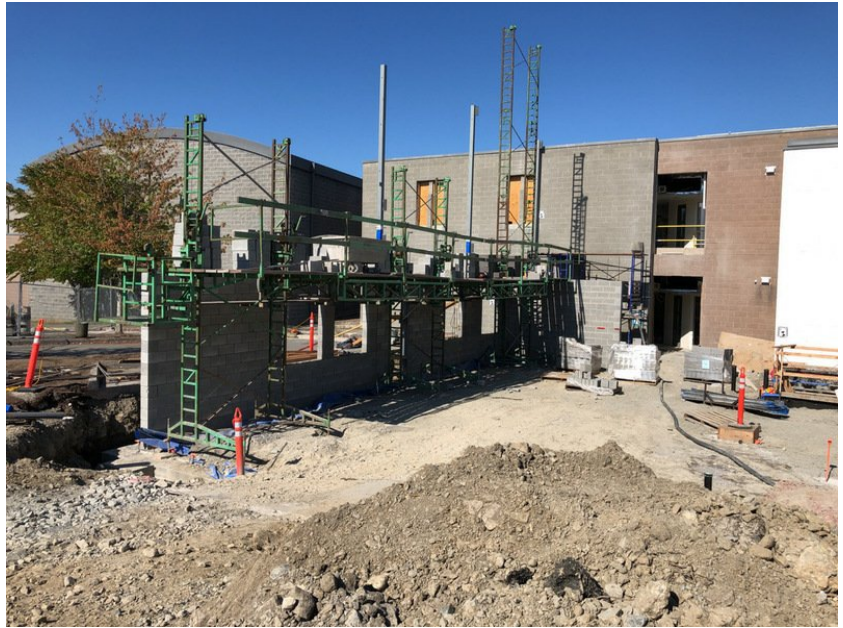
CMU wall in progress on the (plan) east side of the admin portion of the building. Photo facing (plan) southwest).

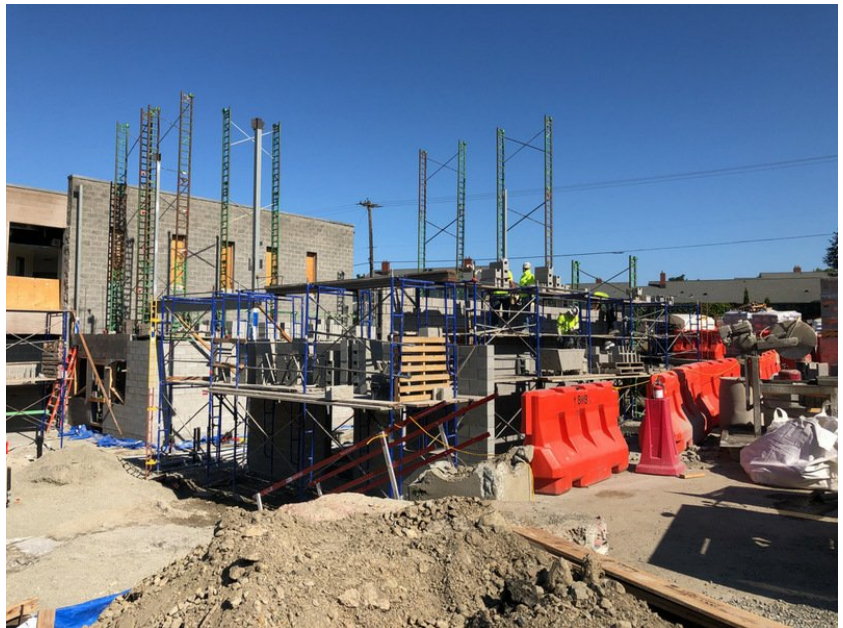
Masonry in progress on the (plan) north and west sides of the admin building. Photo facing (plan) southwest.

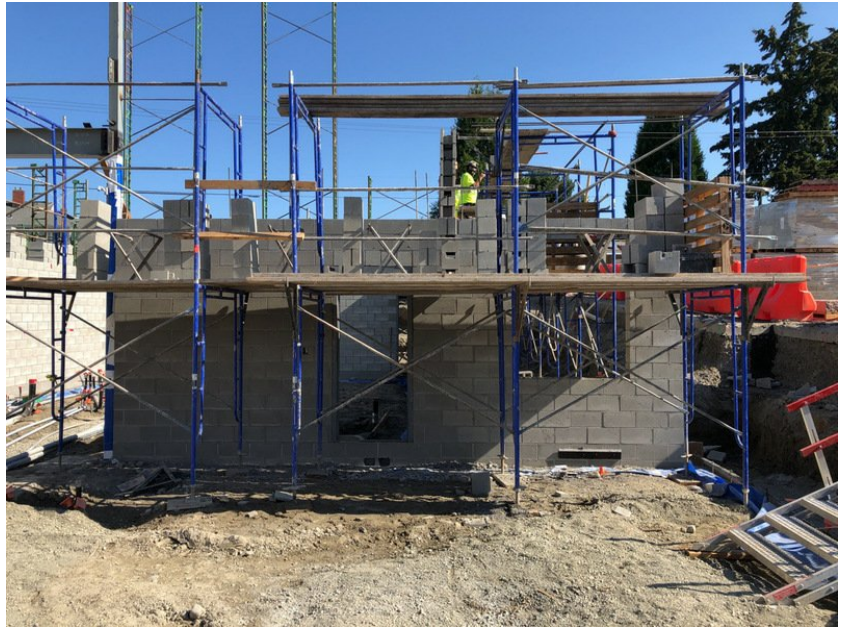
Masonry in progress along the 32 gridline. Photo facing (plan) west.

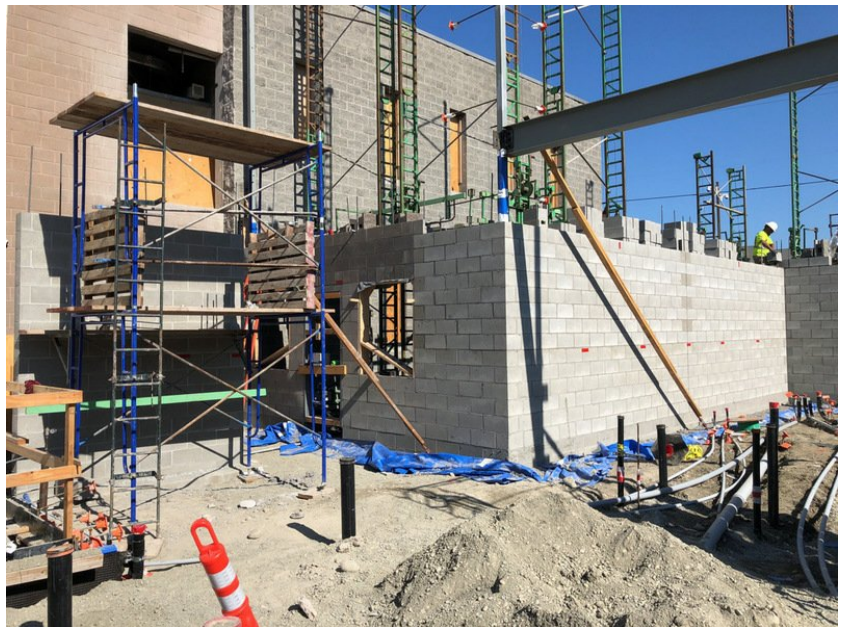
Masonry in progress at gridline 32/DD. Photo facing (plan) southwest

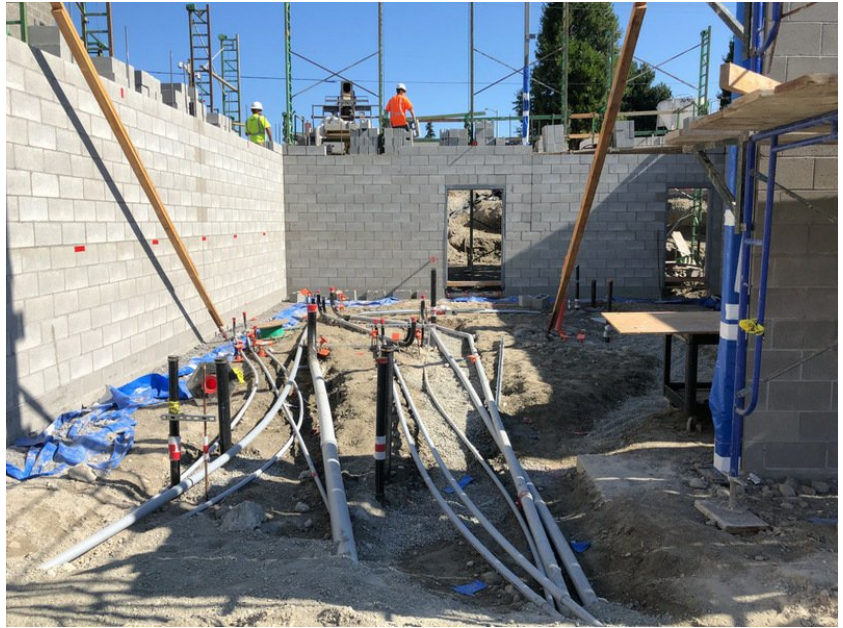
Masonry and underground utilities in progress in the (plan) northeast corner of the admin building. Electrical/comm rooms are on the left side of the photo. Rough opening for the service dock is directly ahead.

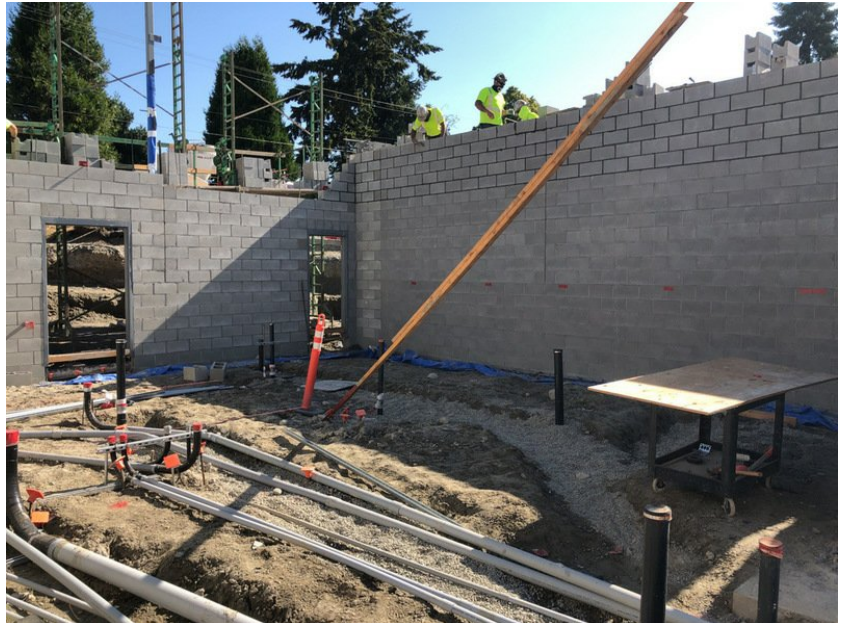
Work in progress in the (plan) northeast corner of the new admin building. Rough openings for the service dock (left) and water entry (right) are shown. Photo facing (plan) northeast.

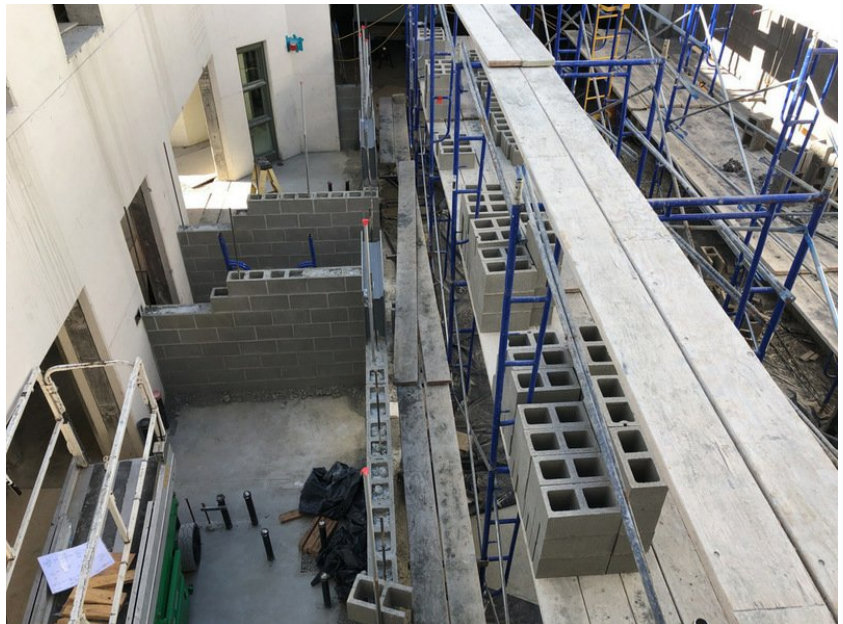
Nurse's station/light court area as viewed from the 2nd floor men's housing area facing (plan) east.

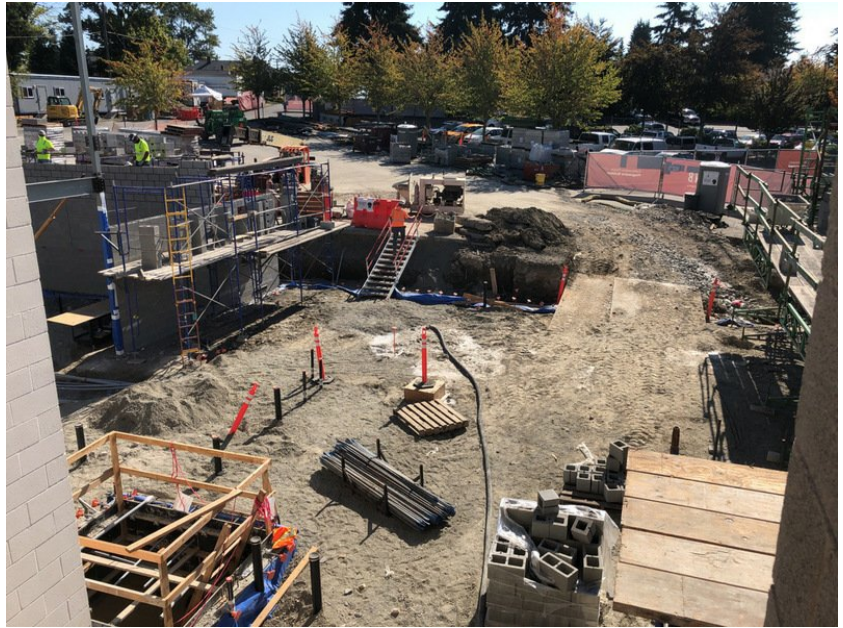
Work in progress at the admin area. Photo from the 2nd floor men's housing area facing (plan) northeast.

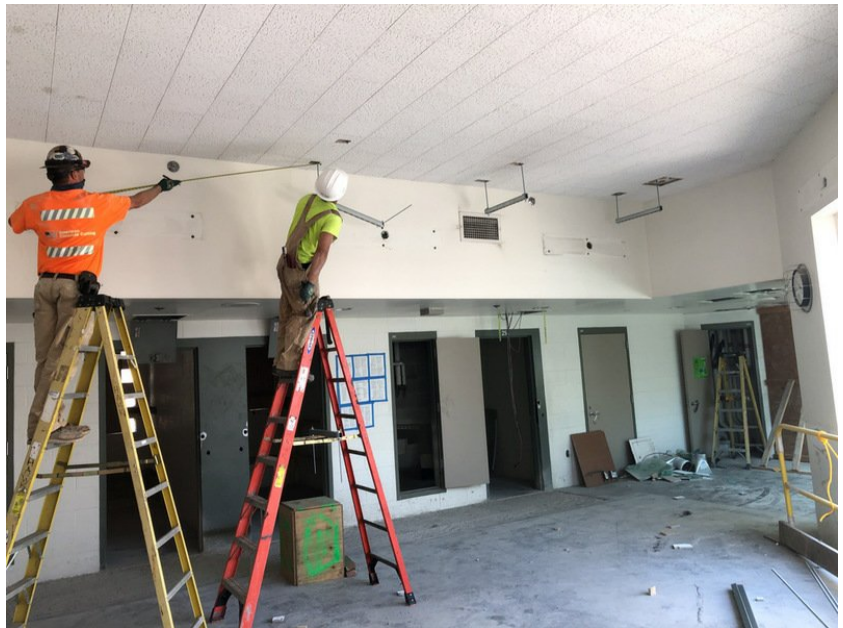
Hanger installation in progress in the women's housing area, 2nd floor facing (plan) south.

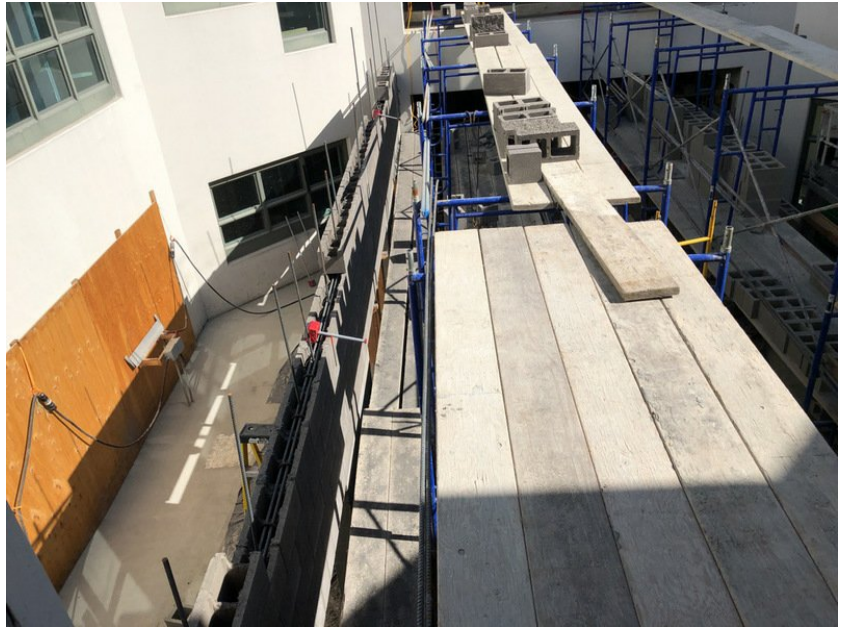
Light court area as viewed from the women's housing area facing (plan) west.

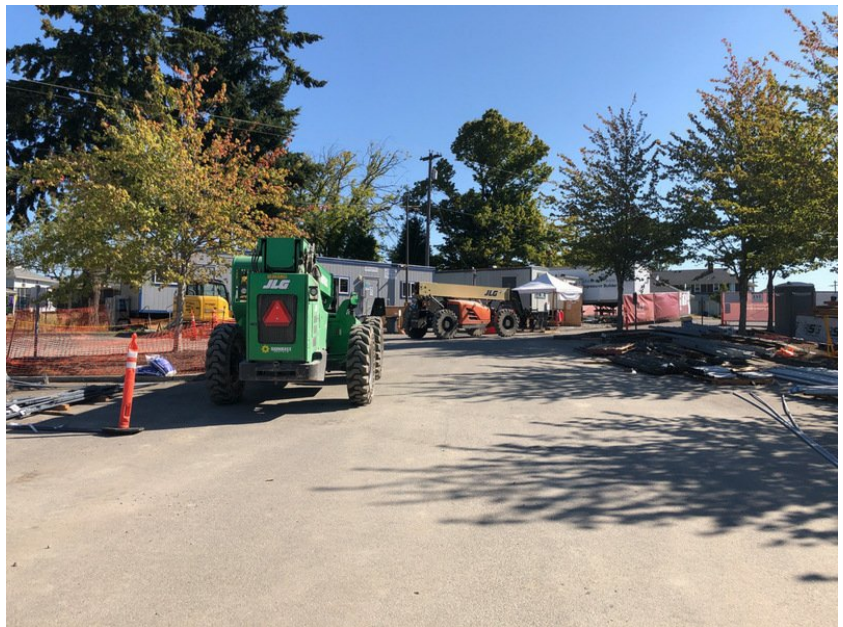
Equipment and materials stored on site.

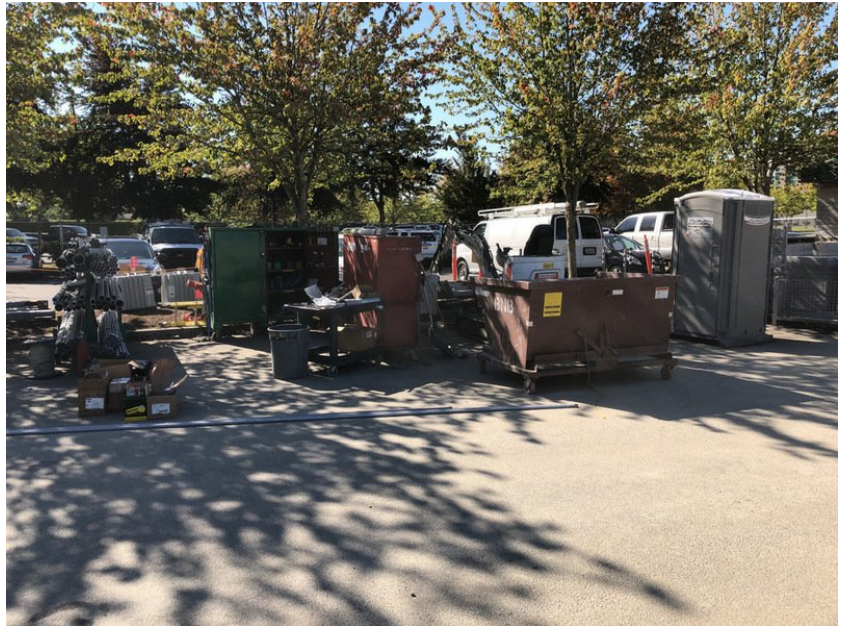
Equipment and materials stored on site.

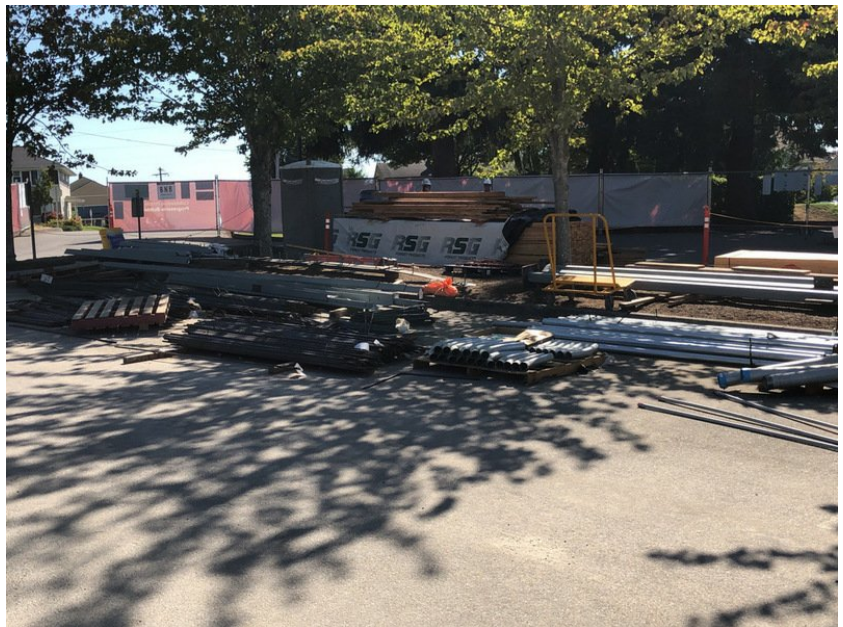
Equipment and materials stored on site.

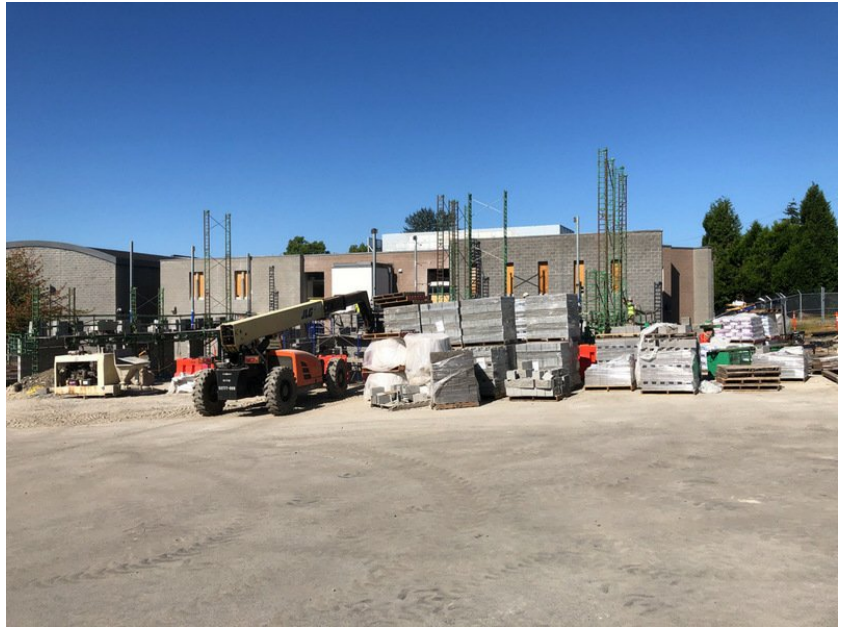
Equipment and materials stored on site.
